THE USE OF CHECK DAMS FOR PROTECTING DOWNSTREAM AGRICULTURAL LANDS IN THE PREHISTORIC SOUTHWEST: A CONTEXTUAL ANALYSIS

William E. Doolittle

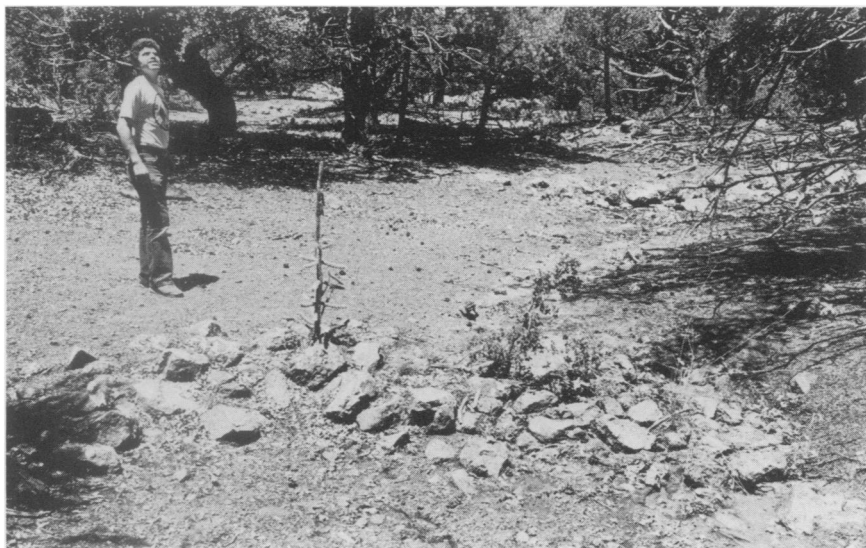
Figure 4. An Upstream View of a Series of Nearly Intact Check Dams in the Upstream Portion of the Channel along the Southern Edge of Site USFS 06-04-109

The lengths of the check dams and the distances between them vary considerably. The longest dam measured approximately 15 m, the shortest only 3 m. In one case, two check dams were only 3 m apart, while the distance between two others in the same stream bed measured 33 m. A direct association in which intervening spaces are short on steep slopes and long on flatter

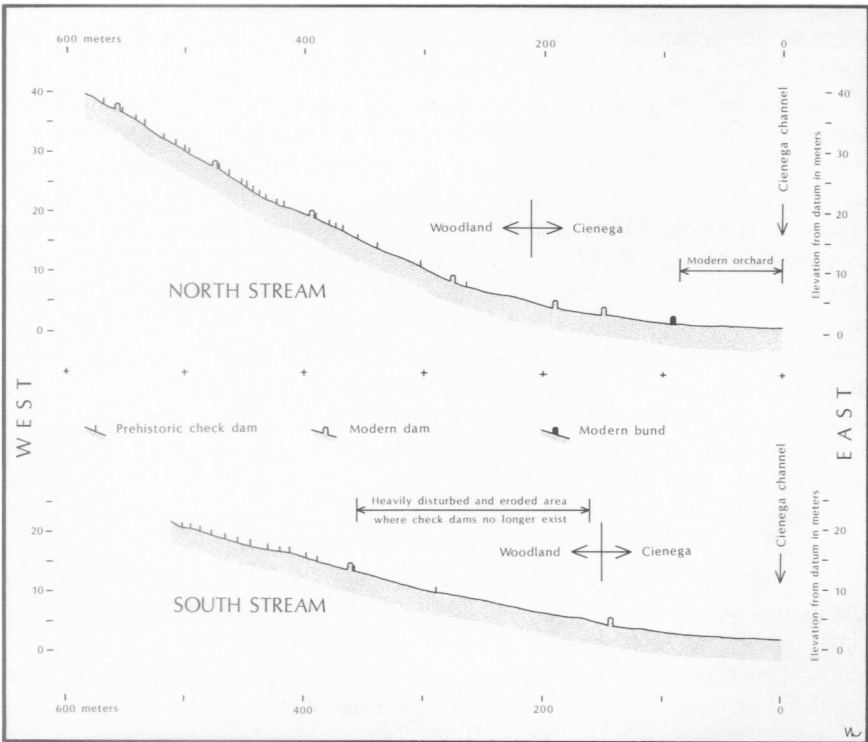
Figure 6. Profiles of Cienega Tributaries Containing Check Dams Illustrated in Figures 4 and 5

*The four check dams for which sediments were analyzed and data are presented here are in the stream along the south side of site USFS 06-04-109. These check dams were sampled because they are the best preserved in the area. Check dam number 7 is the seventh one from the top of the drainage; number 10 is the tenth (see Figure 6).

For the most part, the tributaries as they cross the cienega have profiles (Figure 6) and cross sections that are similar to those of the principal stream. Ponding has occurred where the tributaries converge with the main channel (Figure 11). Here, the tributary and main channel gradients are flat, or nearly

Eight earthen dams are located in the two channels containing ancient check dams near site USFS 06-04-109 (Figure 6). In at least two cases, these relatively recent features partially overlie their prehistoric counterparts. These check dams were built to retain runoff (see, e.g., Wanielista et al. 1984:147-50), probably during the 1930s (Heede 1960). A few large pinyon pines (*Pinus*

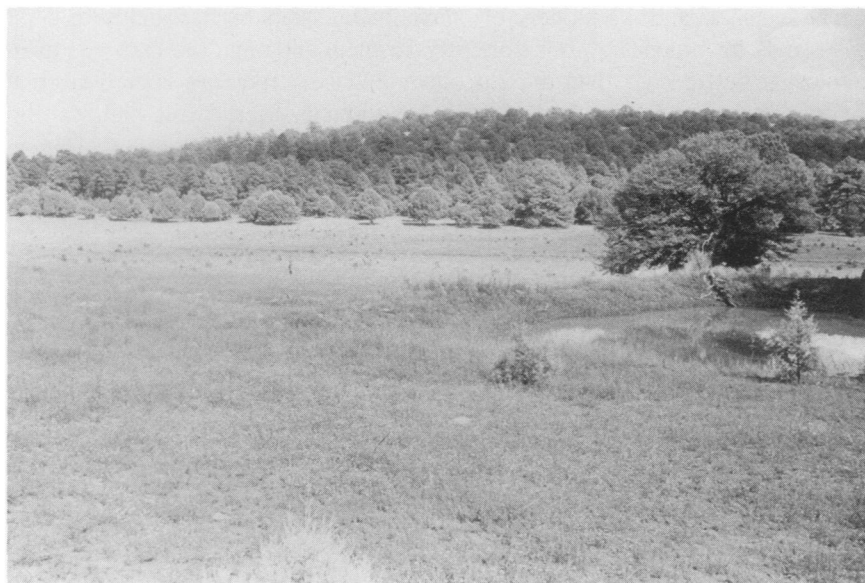
Figure 8. View of Cienega Adjacent to Site USFS 06-04-109. (This view is looking due east from the site. The dark soil, sparse grass, and young junipers characterize the center of the cienega where ponding was a problem. Drainage is to the left. The stock tank on the right also appears in Figure 6 as the modern feature furthest downstream in the south stream.)
